**Flood Control Project Maintenance  
Levee Inspections**

**Fall 2018 Levee Maintenance Deficiency Summary Report**

**Reclamation District No. 1001 Nicolaus**

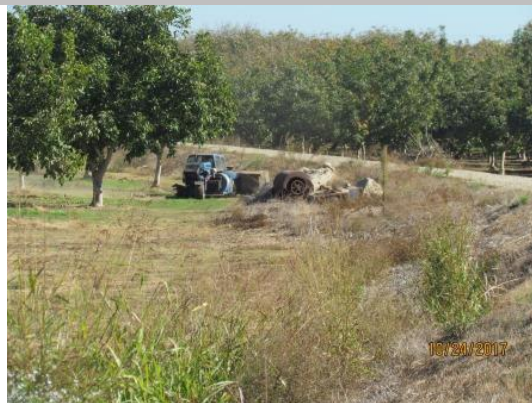
Photo 1 of 1 : FA\_2018\_RD1001\_36\_16\_20180918\_00010.jpg

View lookinf upstream at concrete debris on landside slope.

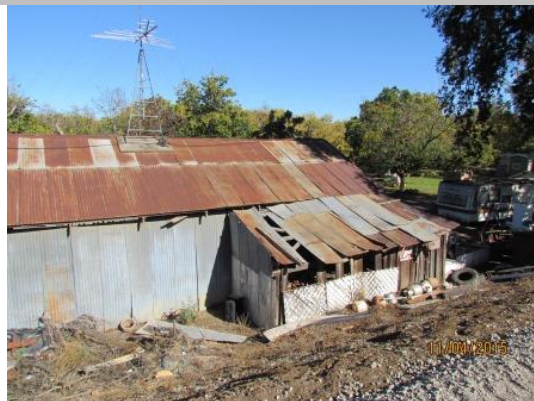
Photo 1 of 1 : FA\_2018\_RD1001\_36\_8\_20180918\_00006.jpg

View of the shed at the landside levee toe.

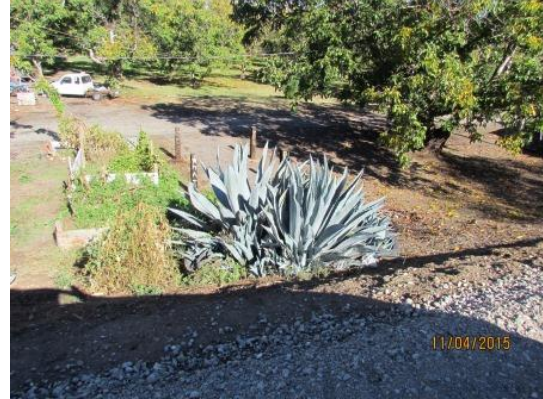
Photo 1 of 1 : FA\_2018\_RD1001\_36\_4\_20180918\_00001.jpg

View of the landscaping at the landside levee toe.

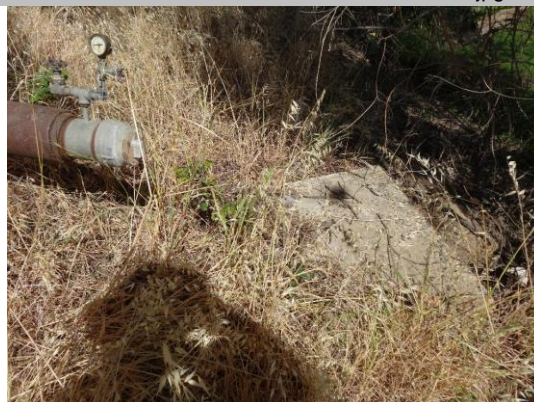
Photo 2 of 3 : UCIP\_FA\_2018\_41673\_22744.jpg

Comment Code						
Inspector Comment						
FS_ID:41673 DS_ID:22536 EP_NO: 5562 Repair Type: Non-Urgent Crossing Status: Found UCIP Comments: 05/23/2013 Pipe appears abandoned and if so should be done so properly. WS pipe plugged with stopper. Seems abandoned. Only abandoned pump base found. (P. Amatya - DWR UCIP) FIELD_STRUCT_DESC: 6-inch coated steel irrigation pipe through the levee, 3.5 feet below the crown. Metal cutoff collar placed on the pipe at the center of the levee crown. Pump was removed. Pump base on the waterside (WS) berm. Shutoff valve on the discharge side of the pump. Foot valve below water on the intake side of the pump. Siphon breaker on the landside (LS) shoulder. Pipe discharges into underground irrigation system on the LS. Power pole and meter box, 10 feet from the landward toe. 1.5-inch flexible conduit through levee, 3.5 feet below the crown. (Pump and irrigation pipe authorized under Permit No. 5562, 1966 - Samuel B. Single). [Additional Reference(s): DWR Levee Log, 1993]. FS Date: 5/23/2013

WS- plugged pipe and pump base.

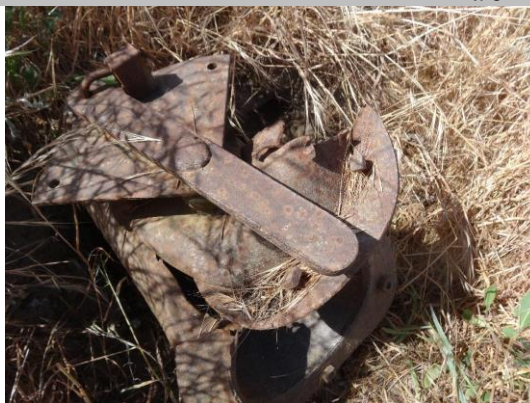
Photo 2 of 3 : UCIP\_FA\_2018\_50740\_22752.jpg

Comment Code						
Inspector Comment						
FS_ID:50740 DS_ID:22529 EP_NO: 2281 Repair Type: Non-Urgent Crossing Status: Not Found UCIP Comments: 07/13/2016 According to district president Joe Henderson, pipe was removed 2-3 years ago. No permit for removal found or evidence of pipe or its removal found. (K. Fazel - UCIP)05/23/2013:- leaky pipe end and erosion on WS.- cracked dirt mound on LS - seems not been used for some time. (P. Amatya - DWR) FIELD_STRUCT_DESC: *REMOVED* 7-inch steel irrigation pipe through the levee, 1.9 feet below the crown. Portable pump mounted on the bank during the summer months. Control valve on the waterside (WS). Steel plate bolted on the WS end during the winter months. Pipe discharges into a 30-inch concrete standpipe at the landside (LS) toe. (Pump and irrigation pipe authorized under Permit No. 2281, 1956 - Willard R. Brown). [Additional Reference(s): DWR Levee Log, 1993]. FS Date: 7/13/2016

WS- seems abandoned or not been used for some time.

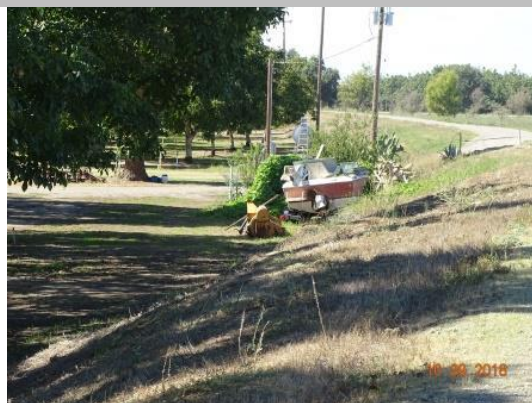
Photo 1 of 2 : FA\_2018\_RD1001\_35\_19\_20181113\_00030.jpg

LM Start	0.53	Rating **	M	Issue No.	19
LM End	0.53	Issue Type +	En	Location *	LS
Category	Earthen Levee			GPS Latitude/Longitude	
				Start	End
Item	Encroachments			38.974371 °	38.974371 °
				-121.481223 °	-121.481223 °
DWR ID	DWR_RD1001_02_f_2016_19				
Comment Code					
AV : Abandoned vehicles					
Inspector Comment					
Remove boat parked at the landside levee toe, Fall 2018.

View of a boat at the landside levee toe. Fall 2018.

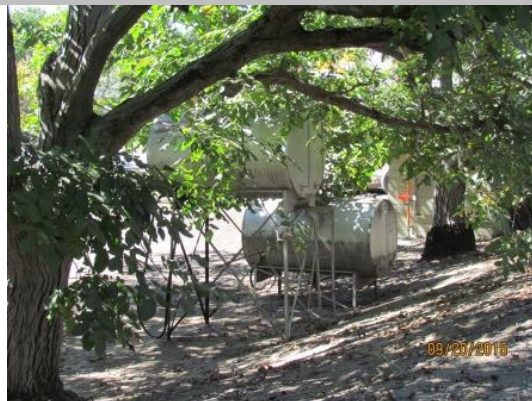
Photo 1 of 1 : FA\_2018\_RD1001\_35\_23\_20180918\_00015.jpg

View of two tanks that are at the landside levee toe.

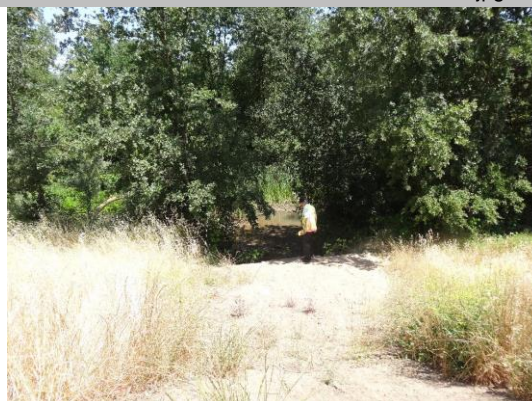
Photo 1 of 3 : UCIP\_FA\_2018\_14008\_23108.jpg

LM Start	2.28	Rating **	M	Issue No.	55
LM End	2.28	Issue Type +	Ma	Location *	
Category	Supplemental			GPS Latitude/Longitude	
				Start	End
Item	DWR UCIP LMA Responsibility			38.967403 °	38.967403 °
				-121.510953 °	-121.510953 °
DWR ID	22543				
Comment Code					
Inspector Comment					
FS_ID:14008 DS_ID:22543 EP_NO: N/A Repair Type: Non-Urgent Crossing Status: Found UCIP Comments: 05/23/2013 - slide gate in inlet pipe on landside - pits on pipe due to corrosion (P. Amatya - DWR UCIP) FIELD_STRUCT_DESC: 36-inch corrugated metal gravity drainage pipe through the levee, 15 feet below the crown. Flap gate and concrete U-shaped headwall at outfall on the waterside (WS) end. Slide gate at inlet on the landside (LS) end. (Reclamation District No. 1001). [Additional Reference(s): DWR Levee Log, 1993. USACE Sacramento O&M Manual 141.1, August 1955, (Station 67+75)]. FS Date: 5/23/2013

WS- overview of waterside of the levee.

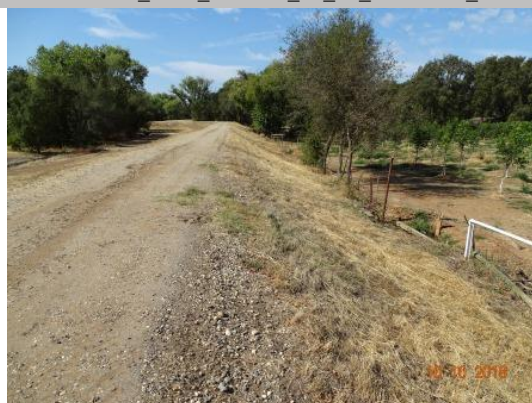
Photo 1 of 1 : FA\_2018\_RD1001\_37\_15\_20181113\_00042.jpg

View looking downstream waterside at the well maintained annual vegetation, Fall 2018.

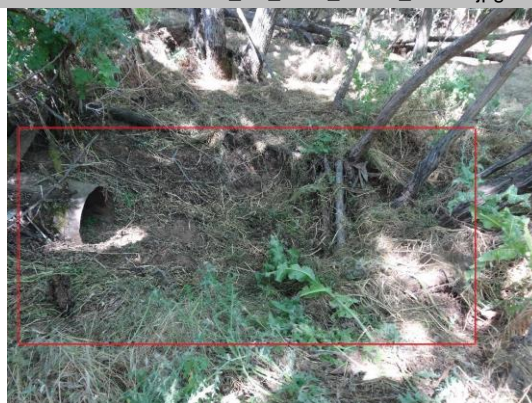
Photo 2 of 3 : UCIP\_FA\_2018\_14128\_23307.jpg

LM Start	0.88	Rating **	M	Issue No.	911
LM End	0.88	Issue Type +	En	Location *	
Category	Supplemental			GPS Latitude/Longitude	
				Start	End
Item	DWR UCIP Field Study			39.006508 °	39.006508 °
				-121.391086 °	-121.391086 °
DWR ID	22549				
Comment Code					
Inspector Comment					
FS_ID:14128					
DS_ID:22549					
EP_NO: 958					
Repair Type: Non-Urgent					
Crossing Status: Found					
UCIP Comments: 05/21/2013 - slide gate on WS not found- needs abandoned properly. (P. Amatya - DWR UCIP)					
FIELD_STRUCT_DESC: *ABANDONED* 24-inch irrigation pipe of an unknown material through the levee, at an unknown depth. Slide gate on the waterside (WS) end. (24-inch irrigation pipe authorized under Permit No. 958, 1944 - Frank B. Lichty and Maggie Lichty).					
FS Date: 5/21/2013

WS- abandoned CMP and depression around it.

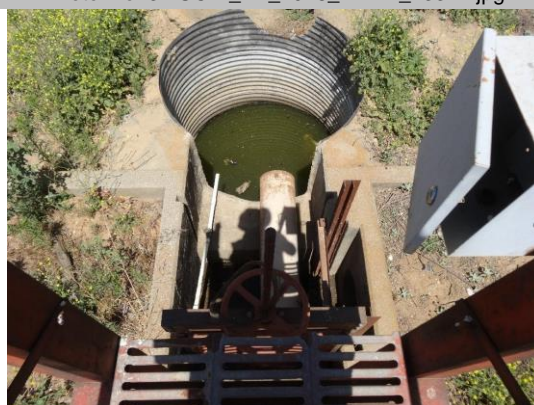
WS- CMP standpipe, pipes and concrete headwall.

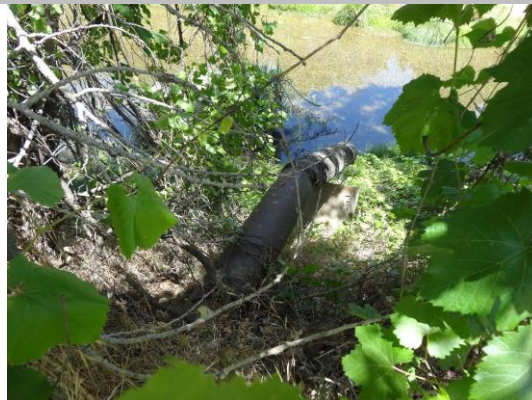
Photo 1 of 2 : UCIP\_FA\_2018\_41722\_23338.jpg

WS- only a steel pipe found on riverbank.

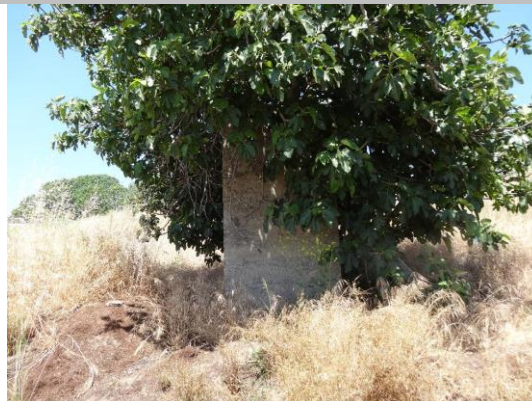
Photo 2 of 2 : UCIP\_FA\_2018\_41722\_23337.jpg

LS- a big tree inside concrete standpipe.

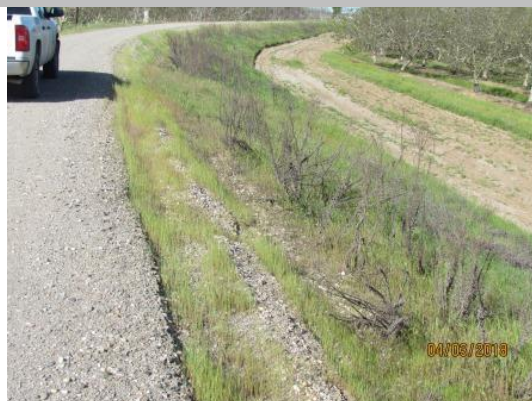
Photo 1 of 1 : FA\_2018\_RD1001\_37\_21\_20180918\_00012.jpg

Erosion on waterside slope still remains as of Fall 2018.

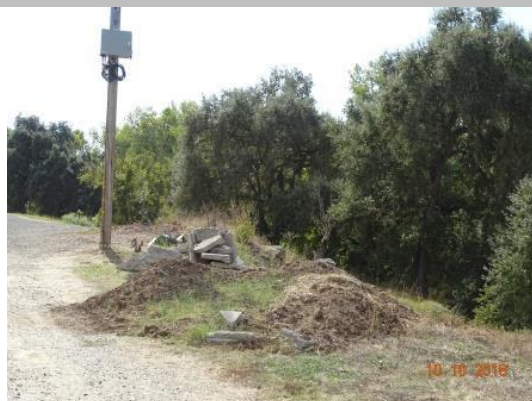
Photo 1 of 1 : FA\_2018\_RD1001\_37\_37\_20181113\_00050.jpg

View looking downstream waterside crown of debris that needs to be removed, Fall 2018.

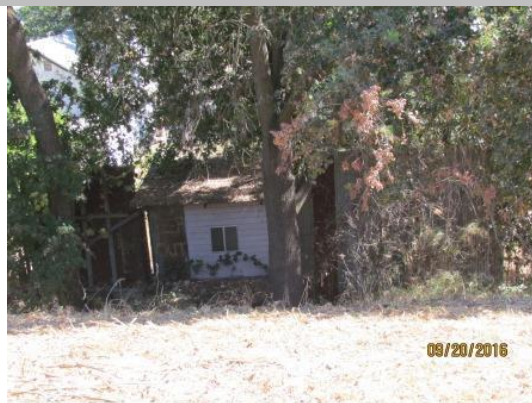
Photo 1 of 1 : FA\_2018\_RD1001\_38\_32\_20180918\_00014.jpg

View of shed at landside levee toe in the easement.

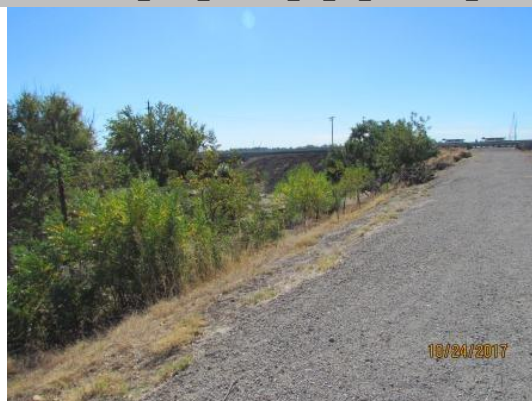
Photo 2 of 2 : FA\_2018\_RD1001\_38\_48\_20180918\_00029.jpg

View looking downstream of fence and landscaping that has been placed by the land owner on levee slope and needs to be removed, Fall 2017.

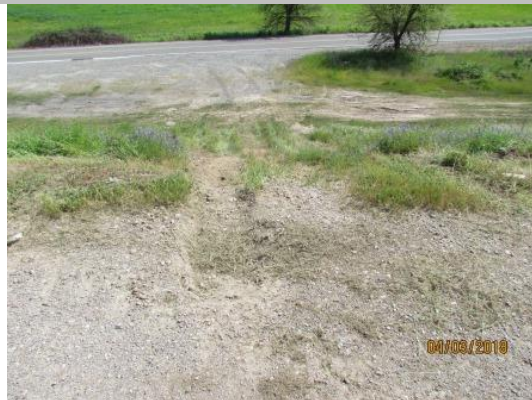
Photo 1 of 1 : FA\_2018\_RD1001\_38\_51\_20180918\_00031.jpg

View of continual vehicles driving up levee slope, should be monitored and maintained.

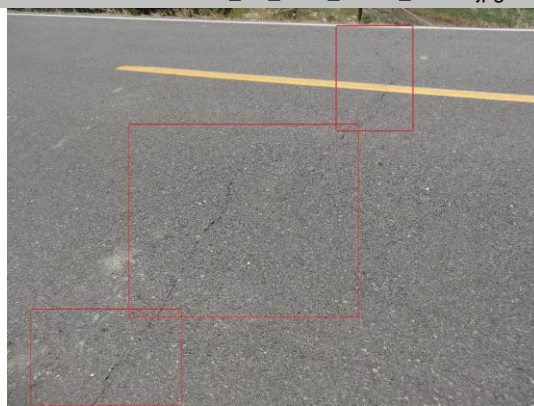
Photo 3 of 3 : UCIP\_FA\_2018\_14563\_24000.jpg

Levee Crown- road surface cracks along the pipe. Needs more investigation.

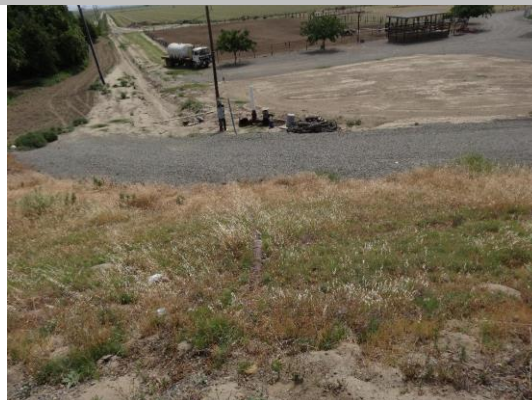
Photo 3 of 3 : UCIP\_FA\_2018\_14544\_23964.jpg

LS- overview of landside, steel pipe on levee slope.

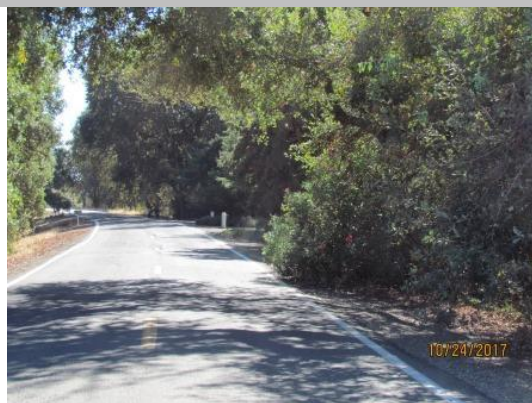
Photo 1 of 1 : FA\_2018\_RD1001\_38\_37\_20180918\_00020.jpg

View looking downstream waterside of landscaping vegetation encroaching onto the levee crown.

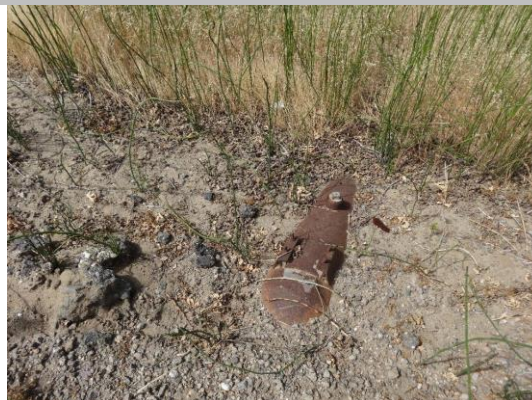
Photo 2 of 3 : UCIP\_FA\_2018\_14627\_24133.jpg

WS- exposed pipe on levee slope.

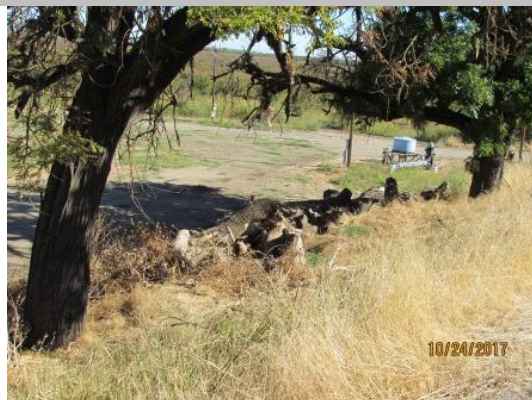
Photo 1 of 1 : FA\_2018\_RD1001\_38\_66\_20180918\_00043.jpg

View of large tree pushed up to the landside levee toe.

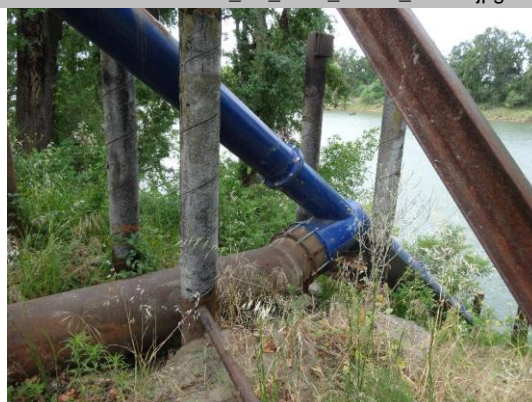
Photo 2 of 3 : UCIP\_FA\_2018\_41723\_23976.jpg

WS- main steel pipe on levee surface (without paint).

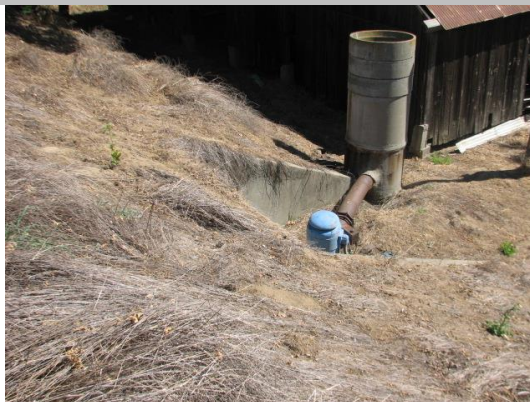
Photo 1 of 1 : FA\_2018\_RD1001\_38\_30\_20180918\_00011.jpg

A retaining wall is within the profile of the slope.

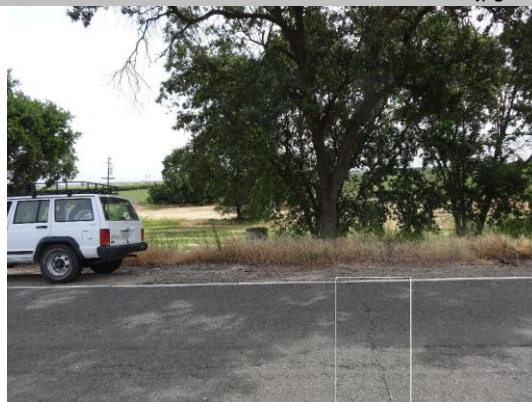
Photo 2 of 3 : UCIP\_FA\_2018\_14548\_23969.jpg

Levee Crown- surface crack along pipe crossing. Needs more investigation.

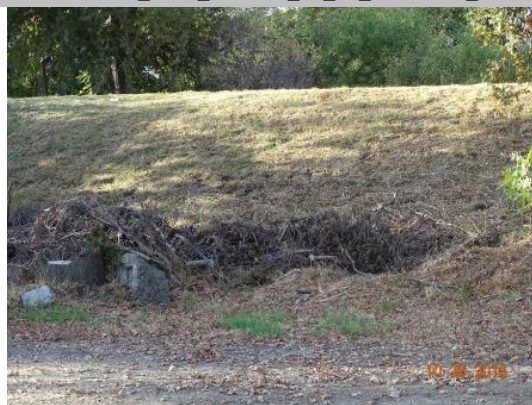
Photo 1 of 1 : FA\_2018\_RD1001\_38\_53\_20181114\_00089.jpg

View looking at landside toe of pruning's on levee toe, Fall 2018.

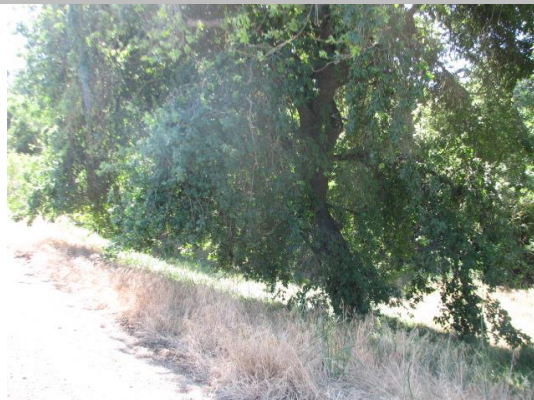
Photo 1 of 1 : FA\_2018\_RD1001\_38\_151\_20180918\_00054.jpg

Trees need to be trimmed up at least 5 feet.

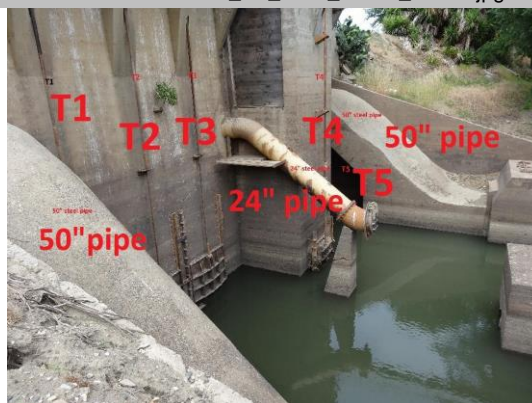
Photo 3 of 3 : UCIP\_FA\_2018\_14393\_23799.jpg

WS- three steel pipes inside tunnel. Fifty inch pipes on left and right. Twenty four inch pipe in middle of the structure as shown.

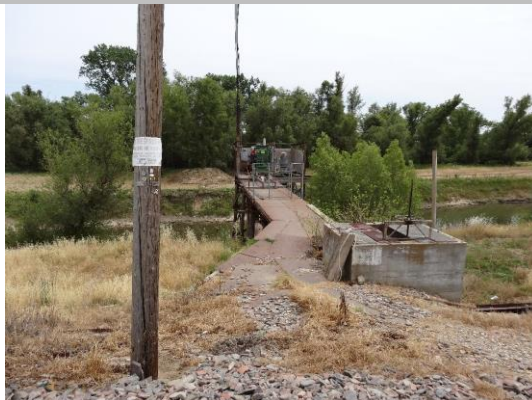
Photo 1 of 3 : UCIP\_FA\_2018\_14486\_23913.jpg

WS- pump station, walkway, and slide gate in concrete box.

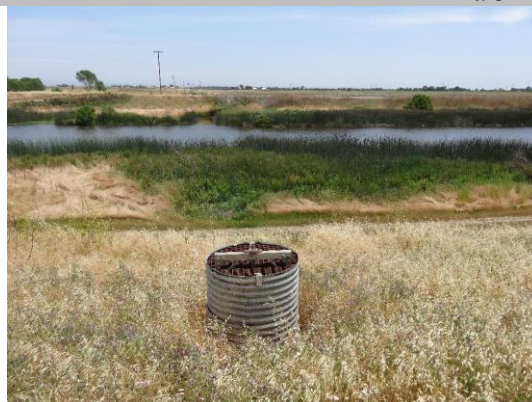
Photo 1 of 3 : UCIP\_FA\_2018\_14223\_23445.jpg

WS- slide gate in CMP riser on levee slope.

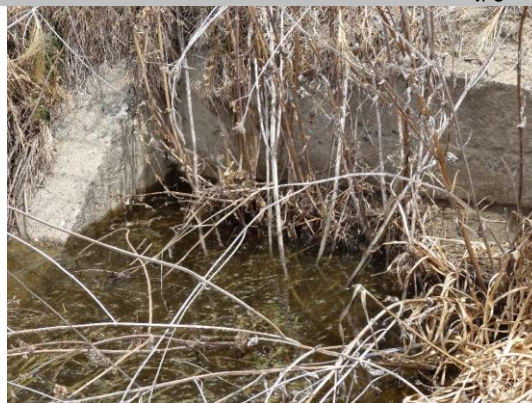
Photo 3 of 3 : UCIP\_FA\_2018\_14223\_23443.jpg

LS- pipe submerged/buried in concrete wing wall on levee toe

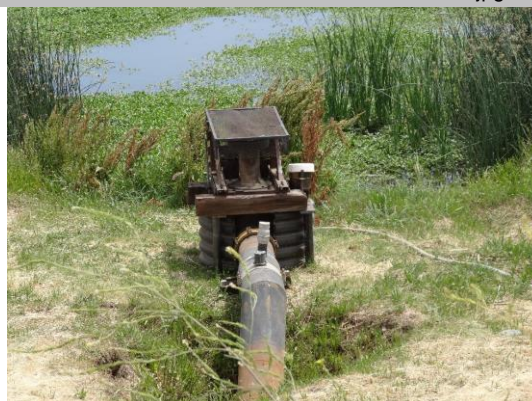
Photo 2 of 3 : UCIP\_FA\_2018\_53424\_23427.jpg

WS- pump and pipe on river bank

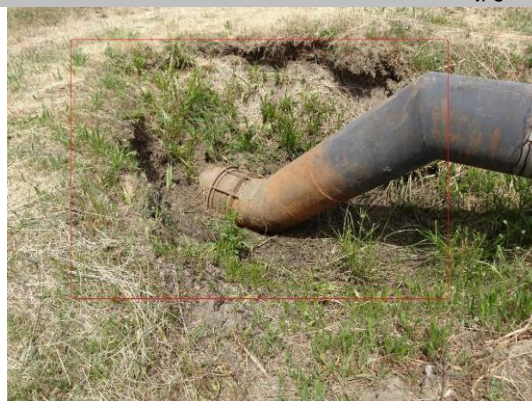
Photo 3 of 3 : UCIP\_FA\_2018\_53424\_23426.jpg

WS- large depression on levee berm at pipe daylight

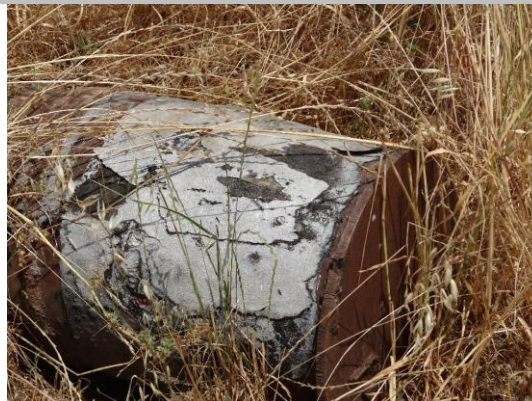
Photo 2 of 3 : UCIP\_FA\_2018\_41674\_23381.jpg

WS- an abandoned end capped pipe on levee slope

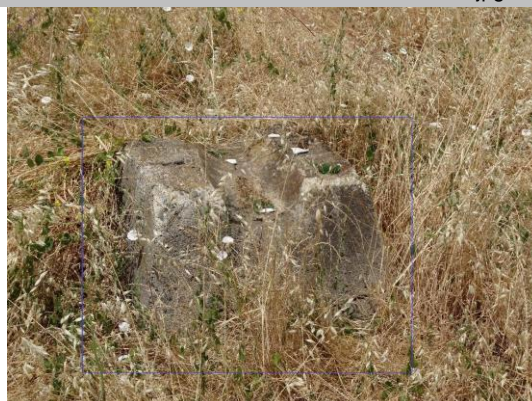
Photo 3 of 3 : UCIP\_FA\_2018\_41674\_23380.jpg

WS- concrete pipe support saddle.

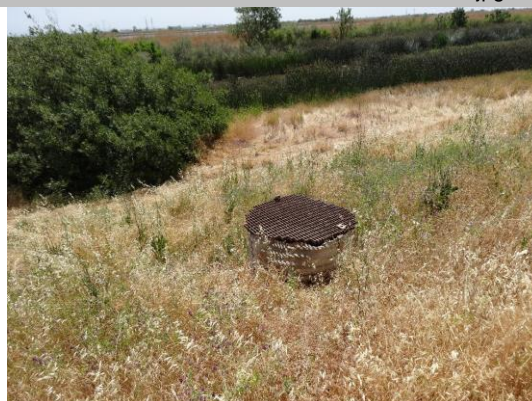
Photo 3 of 3 : UCIP\_FA\_2018\_14167\_23397.jpg

WS- slide gate in CMP riser on levee slope

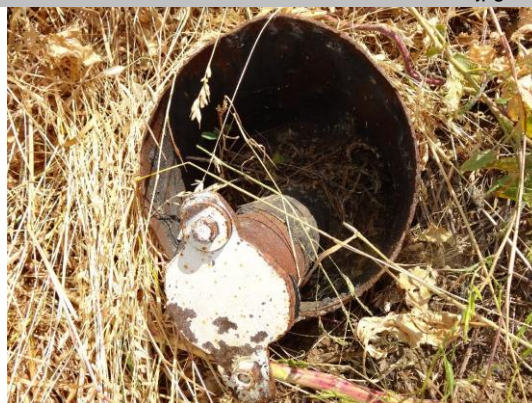
Photo 2 of 2 : UCIP\_FA\_2018\_13523\_22120.jpg

WS- gap between two pipes needs to be filled.

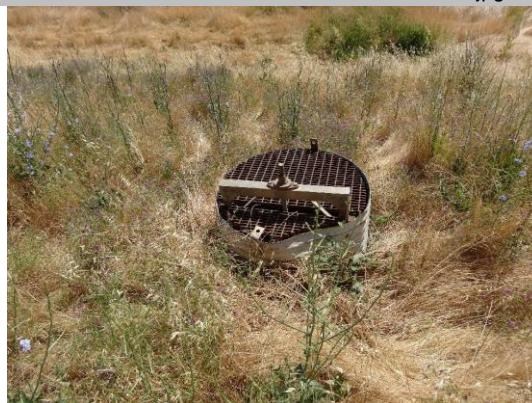
Photo 1 of 2 : UCIP\_FA\_2018\_13509\_22086.jpg

WS- fixed slide gate in CMP riser on levee slope.

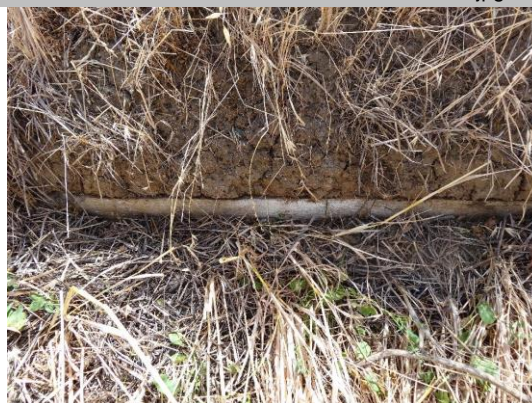
Photo 2 of 2 : UCIP\_FA\_2018\_13509\_22085.jpg

LS- almost burried concrete headwall. Only upper portion of the wall is visible.

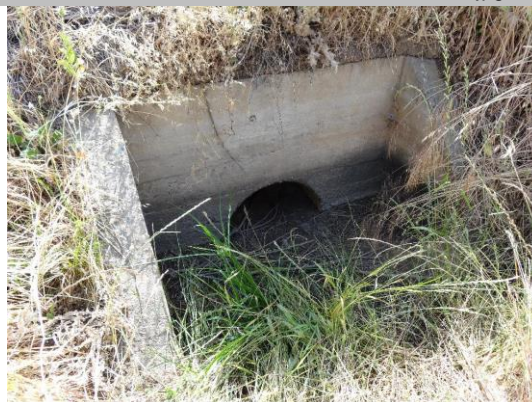
Photo 2 of 3 : UCIP\_FA\_2018\_53425\_22045.jpg

LS- CMP in concrete head/wing wall outlet

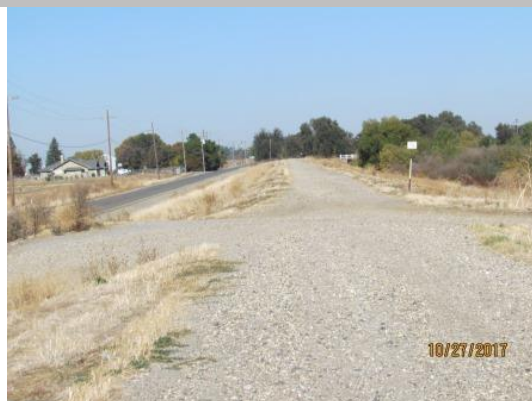
Photo 1 of 1 : FA\_2018\_RD1001\_40\_7\_20180918\_00002.jpg

View of crown where there is cross traffic looking upstream. Monitor this area and fix as needed.

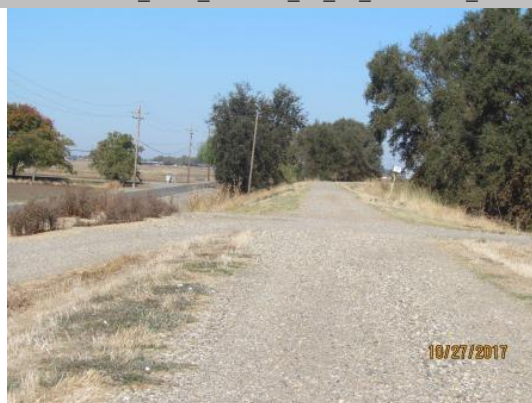
Photo 1 of 1 : FA\_2018\_RD1001\_40\_19\_20180918\_00005.jpg

View of crown where there is cross traffic looking upstream. Monitor this area and fix as needed.

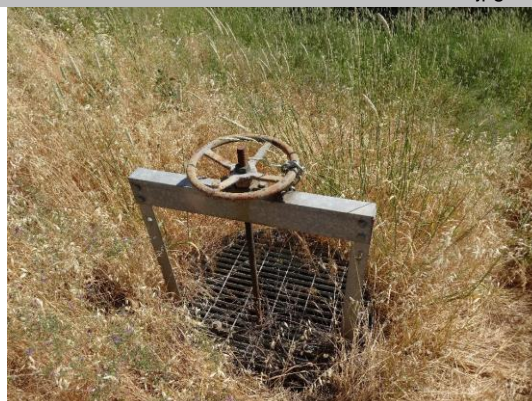
Photo 1 of 3 : UCIP\_FA\_2018\_41724\_22034.jpg

WS- slide gate in CMP riser.

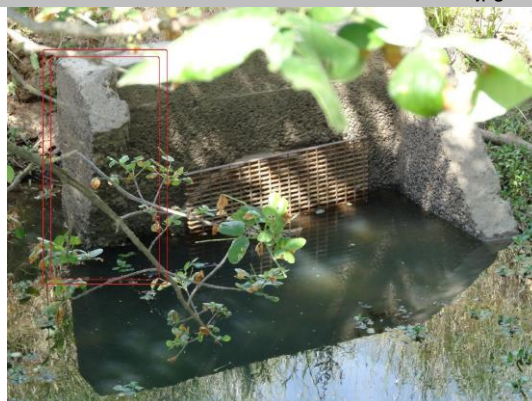
Photo 3 of 3 : UCIP\_FA\_2018\_41724\_22032.jpg

WS- inlet pipe with trashrack in a damaged wing wall

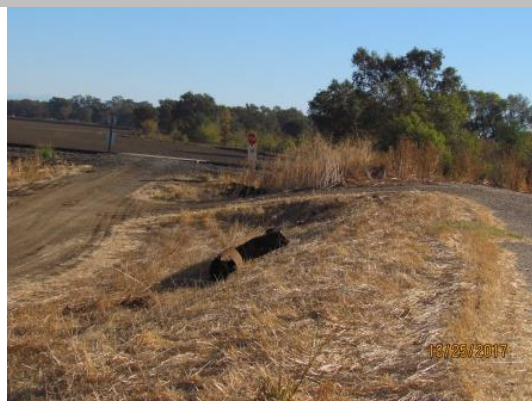
Photo 2 of 2 : FA\_2018\_RD1001\_40\_24\_20180918\_00008.jpg

View of an old piece of pipe lying on landside levee slope looking upstream. Fall 2017.
